# TECHNICAL SERVICE BULLETIN

**British Motor Holdings (U.S.A.) Inc.**

Re: Clutch Judder

'A' Type Transverse  
Power Units

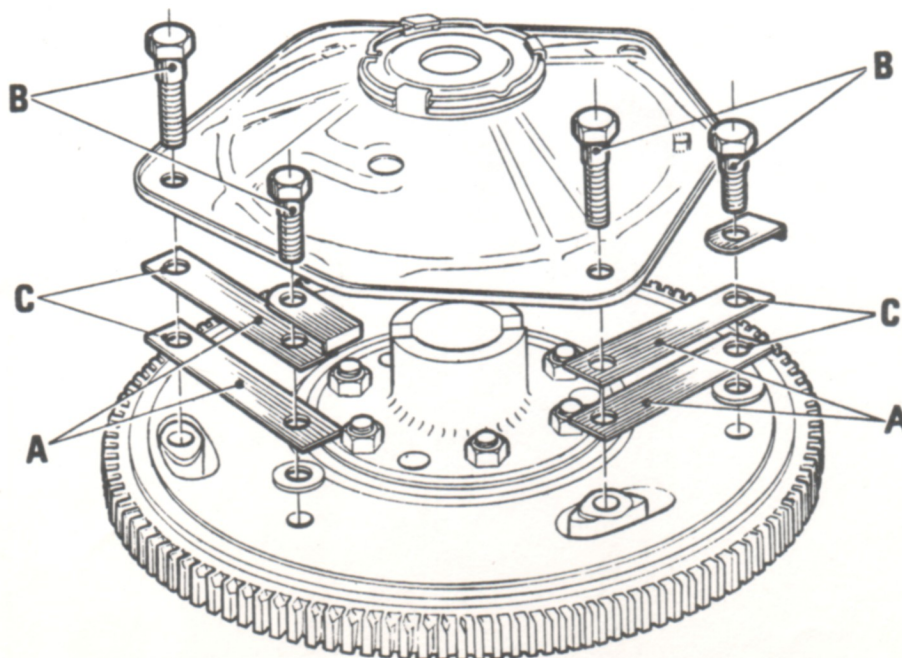
Judder may be caused by incorrect assembly of the driving straps 'A'.

If this method of assembly is not followed, holes 'C' could be out of phase and subsequent tightening down of the screws would cause the straps to buckle and, in effect, foreshorten. This in turn puts the pressure plate out of centre, resulting in judder.

When investigating complaints of judder the above condition is identifiable by a thread form cut into the dowel portion 'B' of the screws, caused by forcing the straps into alignment. Additionally the 'out of phase' condition of the straps would be noticeable after the removal of the dowel screws.

It is essential when fitting the straps to the flywheel and pressure plate that the dowel portion 'B' of the fixing screws (driving pins) enters both holes 'C' in each pair of driving straps before being finally tightened down.
