TECHNICAL SERVICE BULLETIN

British Motor Holdings (U.S.A.) Inc.

February 29, 1968

Re: Right Angled Speedometer Adaptor Failures

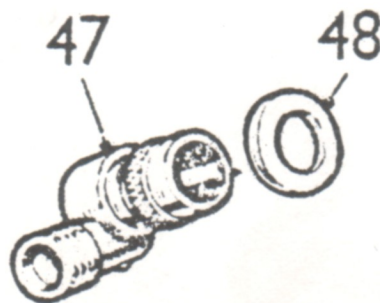
WASHER 3H 550

Repeated failures of the above have, in many instances, been caused by Washer-Adaptor to gearbox Part Number 3H 550 not being fitted when a new right angled drive adaptor is installed.

This causes an excessive end load and premature failure of the right angled drive pinion.
