TECHNICAL SERVICE BULLETIN

British Motor Holdings (U.S.A.) Inc.

May 1, 1968

Re: Assembly of Gear Selector Lever
To Lever Plunger

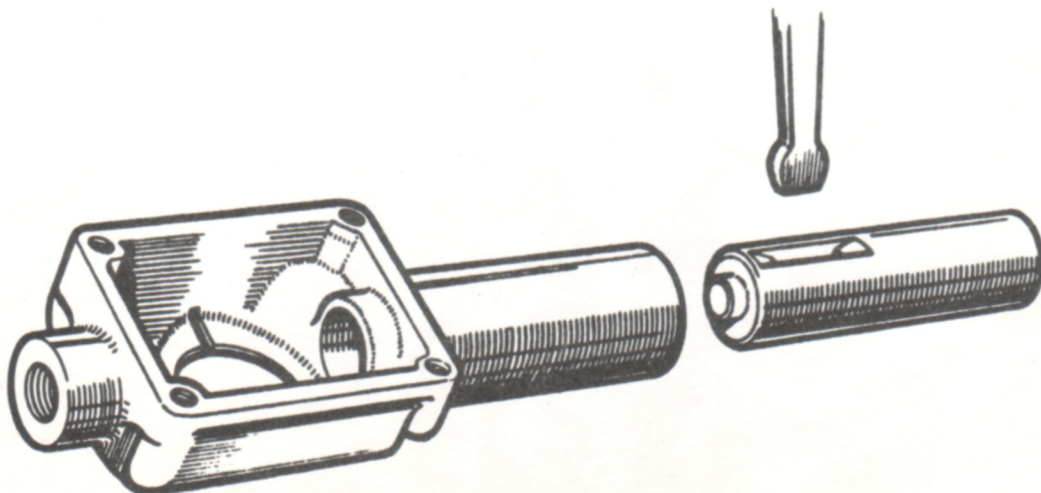
Instances have been reported where, after removal of the gear lever from the lever plunger, the latter has rotated 180° and the lever has been inadvertently reassembled into the unrelieved side of the lever locating slot.

This results in the lever being lifted upwards, thereby overriding the reverse stop on the gear indicator plate and nullifying the effect of the neutral start switch.

If the gear selector mechanism is dismantled, it must be ensured that the lever is inserted into the plunger slot from the relieved side, as shown in the illustration.
