TECHNICAL SERVICE BULLETIN

British Motor Holdings (U.S.A.) Inc.

Re: Rear Clutch Spring Seat

MGC Automatic

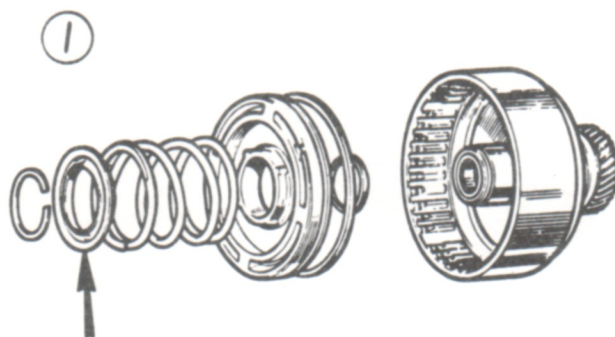
On some MGC Automatic Transmissions it has been found that complaints of

(a) transmission slip on the 2/3 upchange or 3/2 downchange

(b) slip, 'squawk' or judder in reverse

have been due to the rear clutch spring seat 17H 333 (Fig.1) being manufactured incorrectly, thus limiting the rear clutch piston travel and preventing the clutch from fully engaging.
