Confidential  
**TECHNICAL SERVICE BULLETIN**

NO. 2 D 37

**BRITISH LEYLAND MOTORS INC.**  
600 Willow Tree Road • Leonia • New Jersey 07605

<b>SUBJECT:</b>  HIGH INITIAL TRANSMISSION OIL PRESSURE	<b>MODELS:</b>  AUSTIN AMERICA AUTOMATICS
--	---

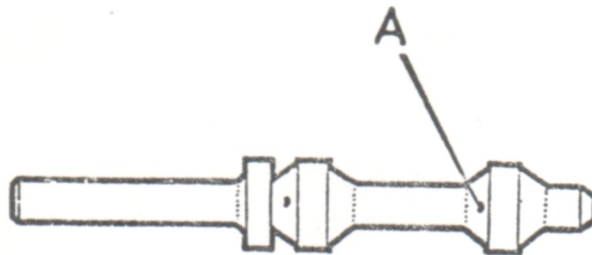
It has been found that under extremely cold conditions the initial oil pressure in the transmission when the engine is being cranked or first started can be abnormally high. This sometimes results in leakage from the oil filter bowl seal and to prevent this possibility the size of the bleed hole 'A' in the regulator valve has been increased.

In the event of complaint on earlier vehicles the modified regulator valves may be fitted.
