# TECHNICAL SERVICE BULLETIN

NO. 2 F 33

STEERING WHEEL CENTER MOTIF  
'POPPING OUT'

AUSTIN AMERICA

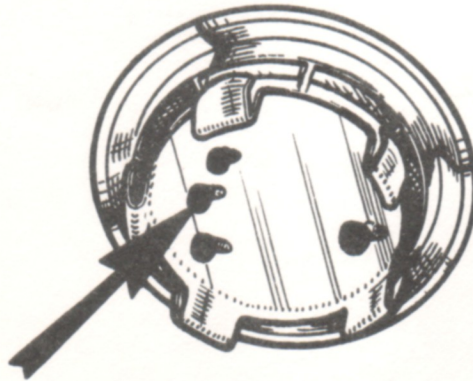
This complaint is usually caused by fracture of the retainer clips and not by errors in sizing of the steering wheel center.

Current stocks of motifs have retainer clips of reduced thickness to allow improved flexibility. These may be recognized by an additional (fourth) adhesive fixing as shown at 'A' in the illustration. The motif part number remains unchanged.
