Confidential  
TECHNICAL SERVICE BULLETIN

NO. 2 D 34

<b>SUBJECT:</b> BRAKE BAND ADJUSTMENTS	<b>MODELS:</b> AUSTIN AMERICA ) AUSTIN 1100 ) Automatics
---	--

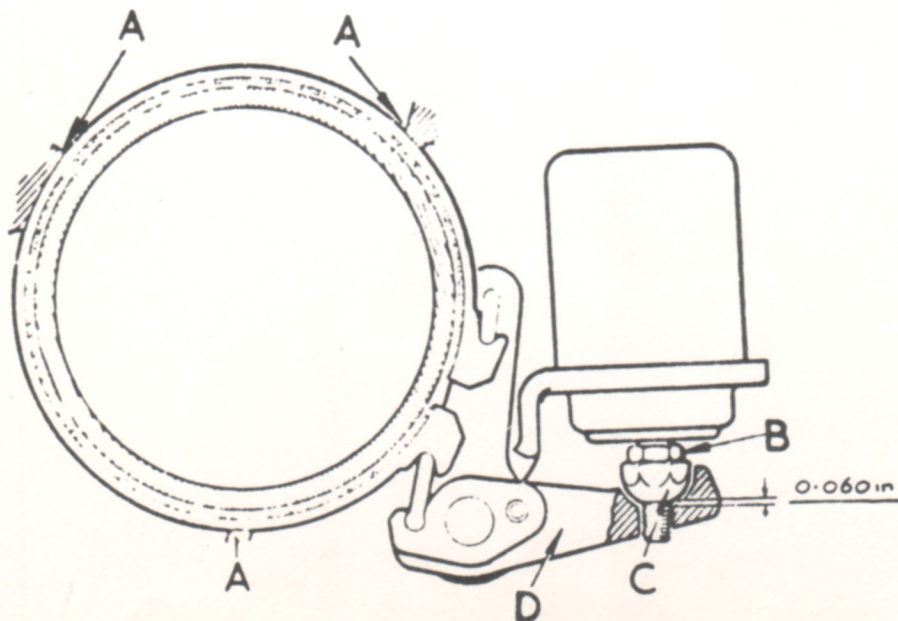
1. Ensure that brake bands are resting against stops 'A' machined in the transmission case. If necessary, slacken locknut 'B' and screw spherical adjusting nut 'C' away from lever 'D'.
2. Adjust spherical nut to provide between 0.040in. to 0.080 in. between nut and its spherical seating in lever. This may best be achieved by screwing nut into lever until no free play exists (taking care not to move band off stops machined in transmission case) and then by unscrewing nut 6 to 12 flats.

If, with adjusting nut fully away from lever, free play cannot be obtained, the nut should be locked in this position.

It is evident that in some instances bands are not being adjusted correctly subsequent to the transmission being dismantled. It is important that the undermentioned procedure be adopted if glazing of the band lining material and consequential power absorption are to be prevented. Note that the procedure is such that band wear is not taken into account and that due to the different mechanical arrangements employed, the travel of the reverse band servo will exceed that of either the 2nd or 3rd gear bands.
