TECHNICAL SERVICE BULLETIN

NO. 73/H/2

SUBJECT:

Marina Air Conditioning Compressor
Pulleys

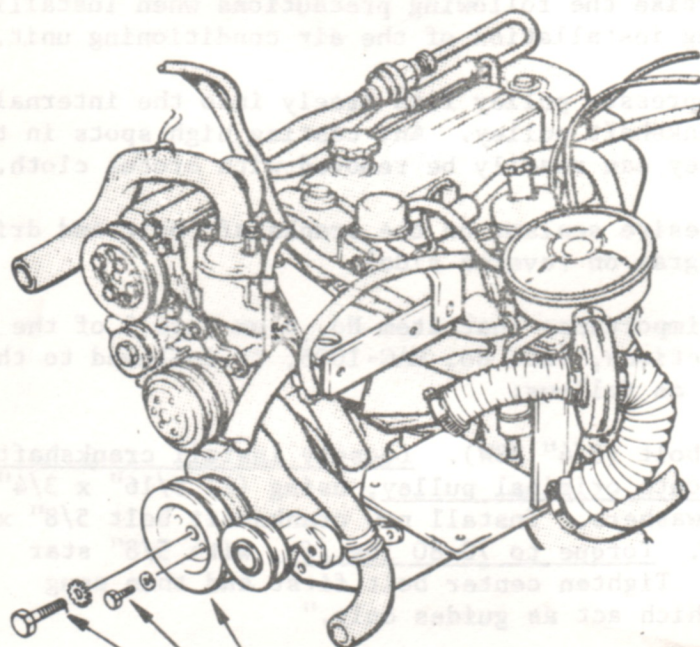
CRANKSHAFT PULLEY 300-6 7223006
(2) 5/16 x 3/4 NF W/LW
5/8 - 16 Thread x 1-1/2 with 5/8" STARWASHER

1. Insure that the compressor pulley fits freely into the internal diameter of the crankshaft pulley. Any casting high spots in the OEM crankshaft pulley can readily be removed with crocus cloth.
2. Use Loctite 242 adhesive sealant on the crankshaft bolt and driving bolts (refer to diagram on reverse side).
3. It is of paramount importance that Item No. 6 on Page 3 of the installation instructions, Part No. HAC-1005, is followed to the letter. This reads as follows:

"Remove crankshaft bolt (3/4" BSW). Loosely install crankshaft pulley (BL-300-6) onto original pulley, using (2) 5/16" x 3/4" NF bolts with lockwashers. Install new crankshaft bolt 5/8" x 1-1/2" (15/16 hex). Torque to 70-80 lbs./ft. with 5/8" star washer (supplied). Tighten center bolt first and then snug both 5/16" bolts which act as guides only."
