## **GROUND POINT AND (OTHER ELECTRICAL CONNECTION) PREPARATION**

**by Dave DuBois**

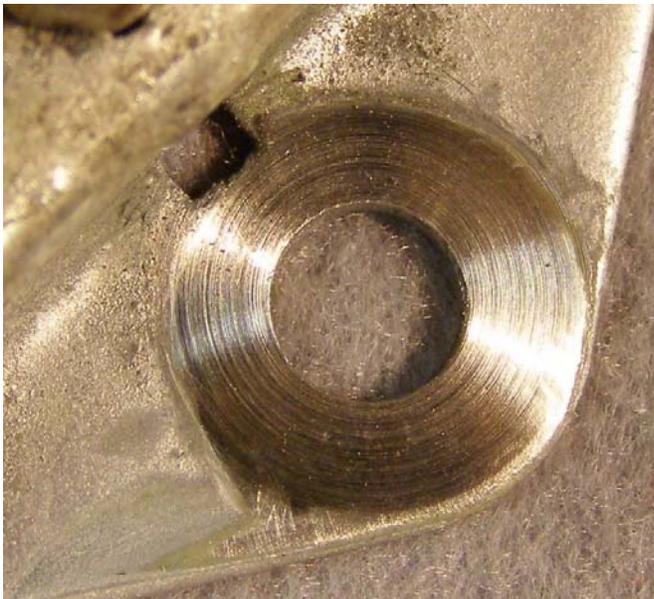
I am going to start with grounds, which is where most of the problems exist. On the surface, grounds look like simple minded connections – it's just a hole in the metal part of the car with a ground wire attached to it. There is, however, more to it than that. For an example, I recently received a turn signal relay used on the T series cars, MGAs and Magnettes. The owner reported flaky operation of the relay and thought he needed either a new one or to have the existing one rebuilt with modern relays instead of the old relays that were originally used. Pictured here is

one of the mounting surfaces of the relay assembly. If you look closely at the cleaned area around the mounting bolt hole, you can see that the paint is quite thick and it originally extended right up to the hole. The first thing I did to insure a good ground connection was to clean both the front and rear surface around the bolt holes down to bright shiny metal. This operation took me about 5 seconds per side on each mounting hole using a piloted end brush in a battery operated drill (see below at the end of the article for information on these brushes). You can see at the edges of the brushed area around the hole that I originally started working with a sanding disk in a Dremel tool, which will also

work, just not as quickly. The preparation of the mating surface of this ground connection rests with the owner of the relay assembly. He will have to insure that the area around the mounting holes on his car are also cleaned right down to shiny metal. All of the surfaces will have to be coated with a good conductive grease made to enhance conductance of electrical joints. One of the best products for this application is Kopr-Shield, a grease with copper particles in it (see below at the end of the article for information on Kopr-Shield). The grease keeps the cleaned surfaces from corroding and the copper particles insures good current flow. There are other products available that will retard corrosion, but not with the copper particles to enhance conductance.

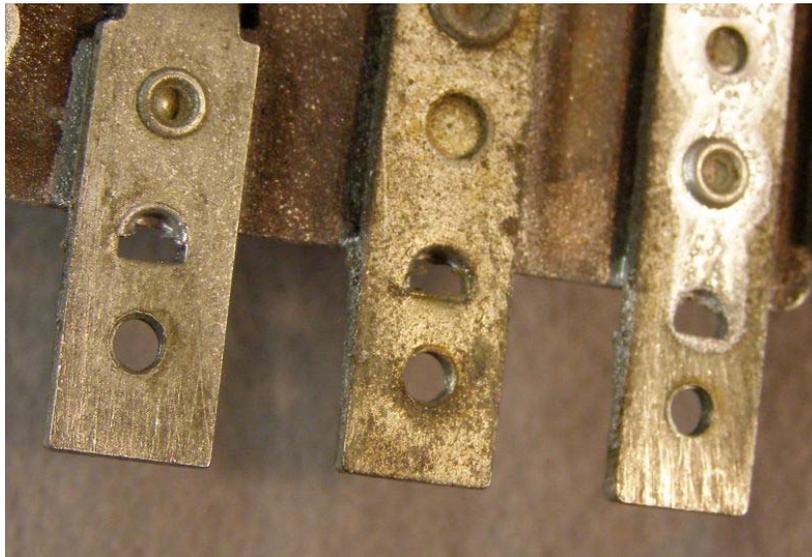
The next area of concern is connections to the terminals of electrical devices like the relay assembly above. These terminals (and the fork or ring terminals on the end of the wires) have to

be clean and free of any dirt, hardened grease corrosion and paint. Remember, dirt, hardened grease, corrosion and paint, while not the best insulators, are definitely not good conductors of electric current and all of these foreign materials must be cleaned off of the terminals in order to have a good connection. In the case of the terminals on the relay assembly, I first started trying to clean the with a small wire brush. While this got the big stuff off, it didn't get some hardened grease and the paint overspray off of the terminals as you can see in this picture to the right (note: this picture is of the back side of the terminals because I didn't get a picture of the front prior to cleaning them). You can see where I wire brushed the terminals and portions of them are somewhat clean, but the center terminal still has hardened grease and dirt on it while the one on the left has paint on it. Contrast this to the lower picture of the front of

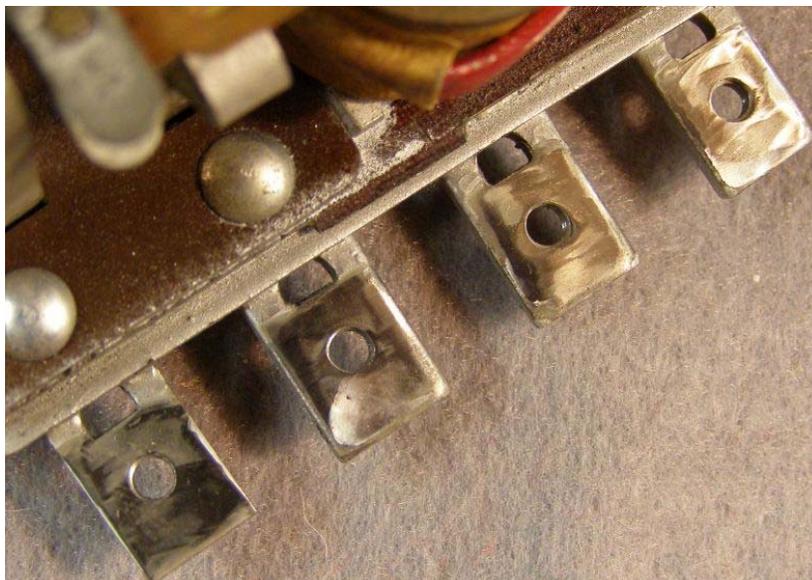
the terminals that were cleaned with a sanding disk in a Dremel tool. The front of the terminals, where the connecting wires will be attached, are again cleaned right down to bright, shiny metal

and are ready for an application of the conductive grease and the terminal ends (also cleaned of all foreign material and corrosion) on the wires.
