# LUCAS 'OPUS' 3 (MK II) ELECTRONIC IGNITION SYSTEM (Fitted to Jaguar "E" Type Series III)

# Lucas 'Opus' 3 (Mk II) Electronic Ignition System

(Fitted to Jaguar "E" Type Series III)

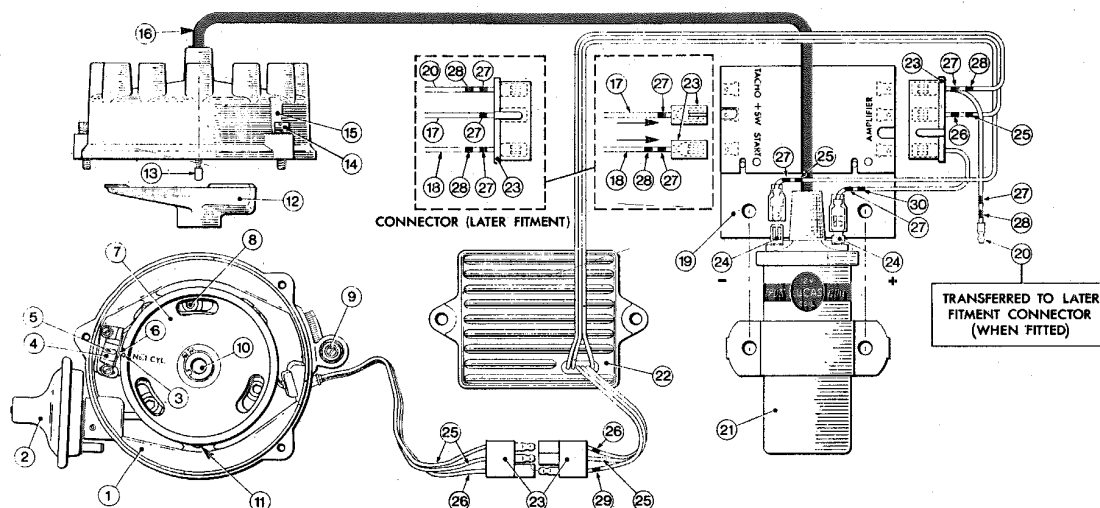
Fig. 1 Lucas 'Opus' 3 (Mk. II) electronic ignition system

The 'Opus' electronic ignition system comprises: Distributor model 36DE12, Amplifier Unit model AB3, Ballast Resistance Unit model 9BR, and a conventional high-performance Ignition Coil model 13C12 (see Fig. 1).

**Note:** External cable connections are shown in Fig. 1

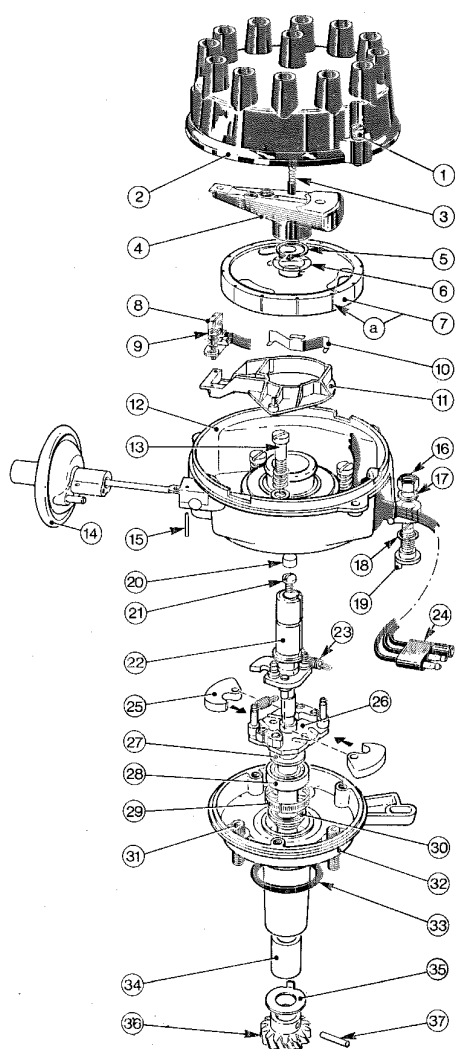
**Fig. 2 Distributor model 36DE12**

**The Distributor:** In addition to the usual conventional centrifugal auto-advance mechanism, retard-type vacuum unit and high-tension (H.T.) rotor arm, the distributor also incorporates an electronic timing rotor and a pick-up module assembly (see Fig. 2). The timing rotor and pick-up module (in conjunction with a separate amplifier unit) replaces the conventional contact breaker and cam.

The timing rotor is a glass-filled nylon disc with small ferrite rods embedded in its outer edge and the number of ferrite rods, and the spacing of the rods, corresponds with the number of cylinders and firing angles of the engine. The timing rotor and the H.T. rotor arm rotate together, with an air-gap (adjustable to

specified limits) existing between the outside edge of the timing rotor and the ferrite core of the stationary pick-up module.

The pick-up module assembly comprises a specially manufactured magnetically-balanced small transformer, with primary (input) and secondary (output) windings. Specialised magnetic balancing of the pick-up module 'E' shaped ferrite core is carried out at the factory by adjusting a small ferrite screw near the bottom limb of the core. **NOTE: Magnetic balancing of the pick-up module cannot alter in service and the ferrite adjusting screw must not be disturbed.**

Automatic control of retard-ignition timing is provided by the vacuum unit which varies the static timing position of the pick-up module in relation to the position of a ferrite rod in the timing rotor. This operates as part of the emission control system that prevents air pollution by eliminating obnoxious fumes from the engine during idling and over-run conditions.

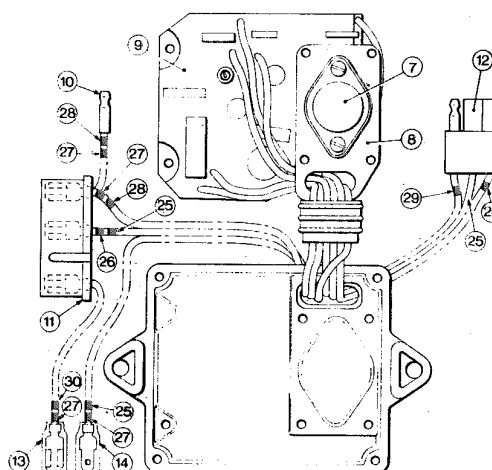
**Fig. 3(a) Amplifier unit with cover removed**

**Amplifier Unit:** This is a die-cast aluminium heat sink with cooling fins. Inside a compartment at the back of the heat sink (enclosed by a cover secured by four

screws) is a printed circuit wiring board assembly, comprising four transistors, a diode and other associated electronic components (see Fig. 3). One transistor is an oscillator, two are amplifiers, and one is a power transistor which functions as an electronic switch to control the primary circuit of the ignition coil. **NOTE:** A small ferrite trimmer screw (oscillator adjusting) is visible in the printed circuit wiring board when the heat sink cover is removed (see Fig. 3a, item 6). This trimmer screw tunes the coupling transformer of the oscillator transistor circuit and the original setting of the trimmer screw must not be disturbed. Also, do not disturb the printed circuit wiring board assembly fixing screws (refer para. (b), page 7).

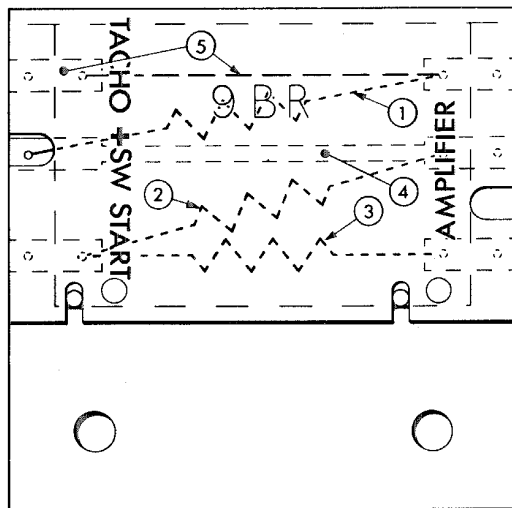
**Fig. 4 Internal connections of ballast resistance unit**

A third resistor in the ballast resistance unit (item 1, Fig. 4) is also connected by external wiring to the amplifier unit, this resistor being associated with the function of one of the transistors.

| 1 Amplifier unit drive resistor | 7.6-9.2 ohms |
| 2 Ballast ignition resistor | 0.72-0.80 ohms |
| 3 Ballast ignition resistor | 0.9-1.0 ohms |
| 4 Straight-through internal connection | |
| 5 Tachometer terminal and straight-through internal connection (incorporated in later units marked 47227) | |

- ★ 47227 is superseded by 47229 which has a tachometer internal connection resistance 100 ohms.

External wiring connects two resistors (items 2 & 3, Fig. 4) in series with the ignition coil primary winding,

bracket (see Fig. 4). If the ballast resistance unit develops a fault, it cannot be repaired and must therefore be renewed.

If so, switch off the ignition and extend the test by checking the resistance of each of the resistors in the ballast resistance unit (use a good quality battery-operated ohmmeter and refer to Fig. 4). If necessary, renew the ballast resistance unit.

**Ballast Resistance Unit:** Check with the ohmmeter, the resistance of each of the resistors (refer Fig. 4).
